WATERSHED MANAGEMENT ISSUES

Debbie Hughes
New Mexico Association of Soil & Water Conservation Districts
163 Trail Canyon Road
Carlsbad, NM 88220

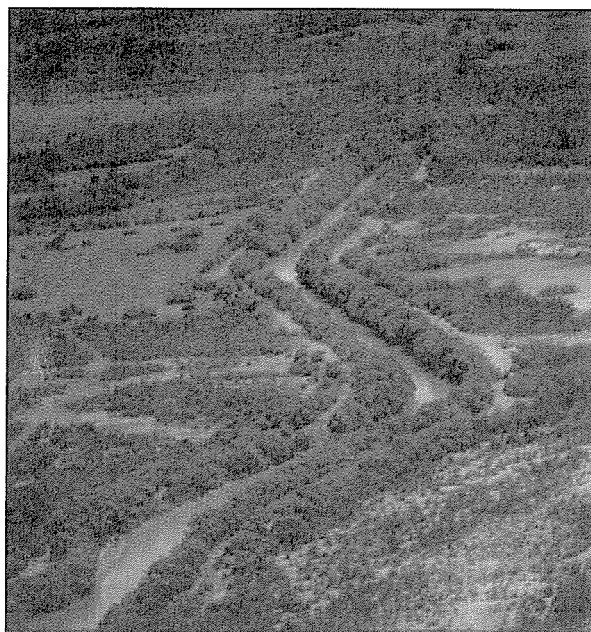
Figure 1. One-hundred foot buffer zone along the Pecos River.

Another effort aimed not at the top of the watershed but rather in the river basin itself is the Pecos River Native Riparian Restoration Project. The Board of Directors for the project comprises the Carlsbad Irrigation District, Carlsbad SWCD, Central Valley SWCD, Chaves SWCD, Dexter-Hagerman SWCD, Pecos Valley Artesian Conservancy District, and Peñasco SWCD. The objectives are to demonstrate native wetlands and wildlife habitat improvement through salt cedar management; demonstrate effective, economical and environmentally sound salt cedar control; and monitor possible hydrologic effects from salt cedar control and management. The project area is approximately 5,000 acres. The area had to be mechanically cleared for the baseline studies and ten monitoring wells were drilled. Clearing was done around the existing groves of cottonwood and black willow. Roots were then sprayed with a herbicide mixture of Arsenal and Round-Up, with die mixed in so that treated areas could be seen. Some re-sprouting occurred and was treated with a carpet-roller attached to a tractor.

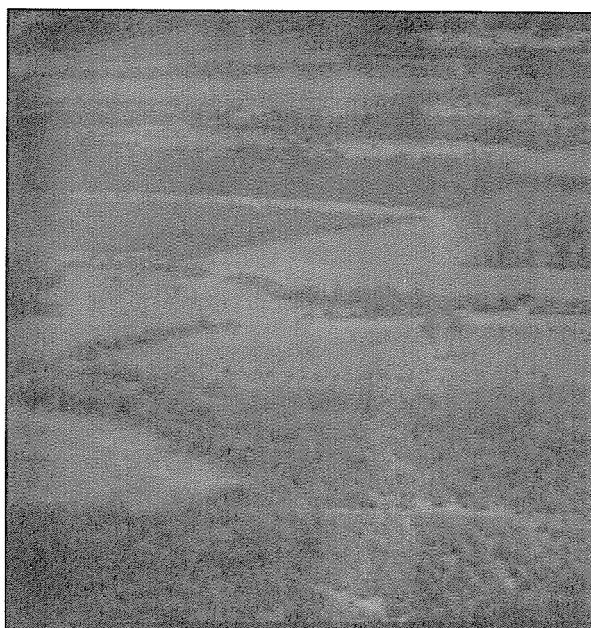
Figure 2. Cottonwood-black willow groves within the restoration area.

The wildlife part of the study focused on all types of animals from birds to mammals to reptiles. The day finally came to treat the large areas and we used a fixed-wing airplane, carefully excluding the cottonwood areas. Much of the area was covered with a canopy of salt cedar. Other areas did not support much of any type of vegetation because of the soil quality. Herbicide was very cautiously applied in the demonstration area, leaving a 100-foot buffer zone along the river (Figure 1). We think we did a pretty good job. The cottonwood-black willow groves still look healthy and should thrive without the competition from the salt cedar that was killing them (Figure 2).
